# MOULD FUNGI AND INDOOR AIR QUALITY IN OLD TRAPPER HUTS AT SVALBARD

Johan Mattsson, Mycoteam AS, johan.mattsson@mycoteam.no  
 Anne-Cathrine Flyen, The Norwegian Institute for Cultural Heritage Research, anne.flyen@niku.no

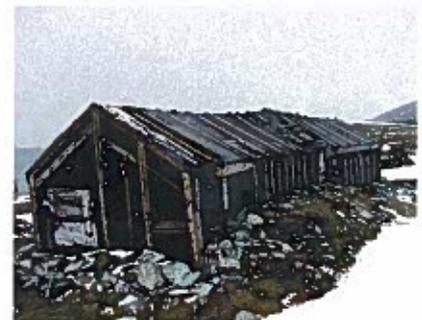
In the early 1900 several trapper huts and buildings related to industrial activity were built at Svalbard. The buildings consist mainly of wooden materials and they are constructed in an unsophisticated way, with the floor beams and other wooden materials in direct contact with the soil. Walls and roof in the buildings are either massive timber structures with wooden panel, or timber frame work with wooden panel on both sides. In some cases the exterior walls are covered by dense bitumen felt in order to prevent the wind blowing through the walls.

A trappers hut with a thick layer of turf for insulation purposes. This keeps the water content high inside the walls

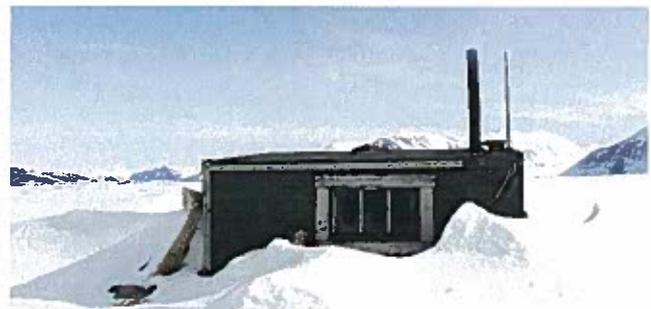
Of the 14 buildings where air samples were taken, the results showed that five of them had no sign of unnatural occurrence of mould spores regarding to amounts of types and four buildings with a minor influence of undesired mould exposure. Five buildings had an unacceptable indoor air climate, as shown in the figure.

It is shown that the mould damages can cause severe negative influence on the indoor air quality in the old trapper huts. Several of the buildings are more or less frequently in use, and further use of these buildings is not recommended before proper remedial treatments have been done. The repair work includes a need for both extensive dismantling of floor and wall constructions and improvement of protection against further moisture conditions. Unfortunate, some of the measures are in conflict with the desire of doing as less impact as possible on the protected buildings.

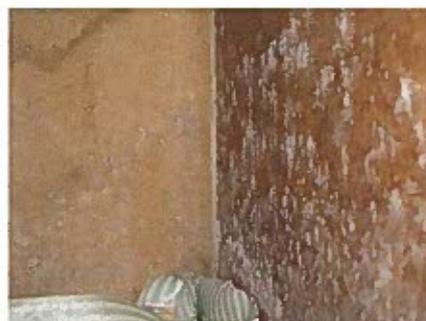
The mould species *Penicillium chrysogenum* was commonly found
