Preventive methods against biodeterioration of protected building materials

Johan Mattsson, Mycoteam as
Anne-Cathrine Flyen, NIKU

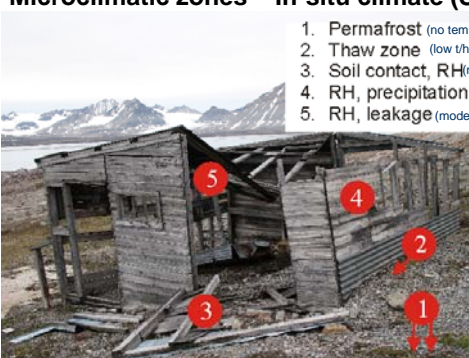
Microclimatic zones – In-situ climate (Svalbard)

1. Permafrost (no temperature/no water)
2. Thaw zone (low t/high w)
3. Soil contact, RH (moderate t/high w)
4. RH, precipitation (high t/high w)
5. RH, leakage (moderate t/low w)

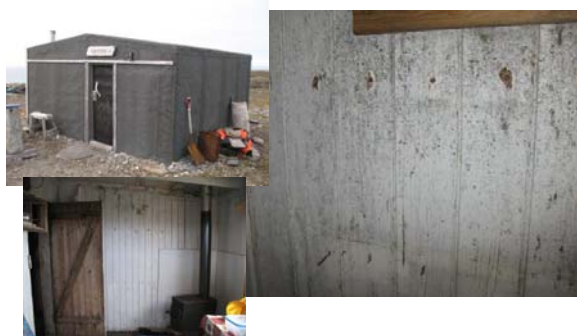
Mould growth - condensation

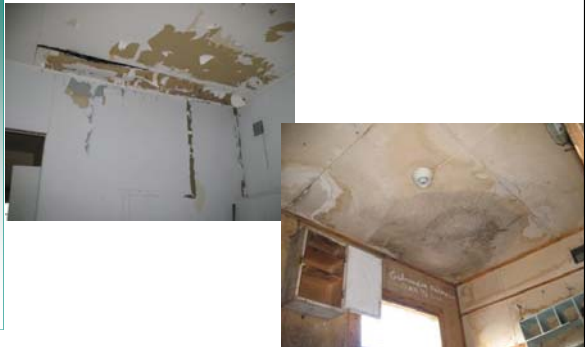
Mould growth - leakage
