Wood-decaying fungi in protected buildings and structures on Svalbard

Mattsson J, Flyen A-C, Nunez M, 2010. Wood-decaying fungi in protected buildings and structures on Svalbard. *Agarica* 2010 vol. 29, 5-14.

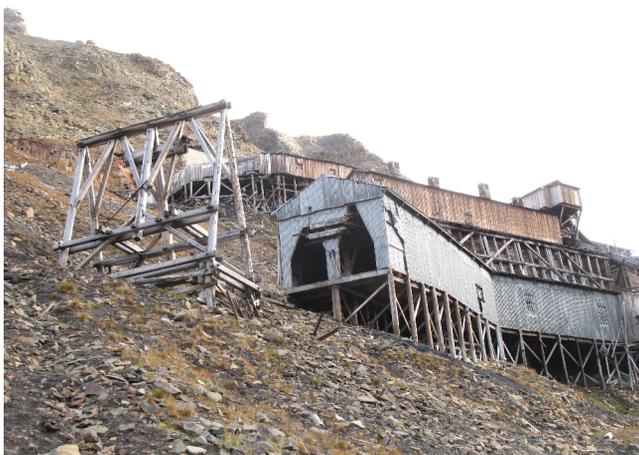
Figure 1. On Svalbard there are many wooden constructions left from earlier industrial activity.

Spread around the coast of the islands of the Arctic Archipelago Svalbard are several trappers' cabins and buildings related to industrial activities (Fig. 1), mostly from the beginning of 20th century (Dahle et al. 2000). The buildings consist mainly of wooden materials, and they are constructed in an unsophisticated way, with the floor beams lying directly on the permafrost ground and with other wooden materials in direct contact with the soil (Fig. 2). Walls and roofs are either

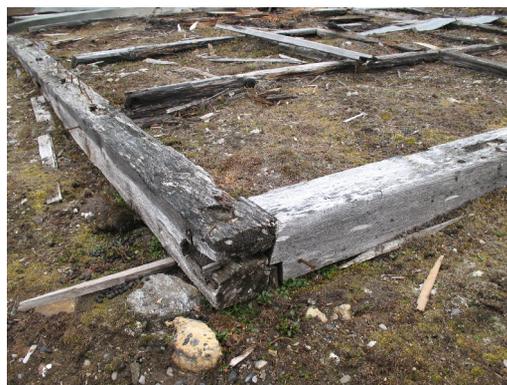
Figure 2. Wood in soil contact is decayed by both soft-rot and brown-rot fungi.

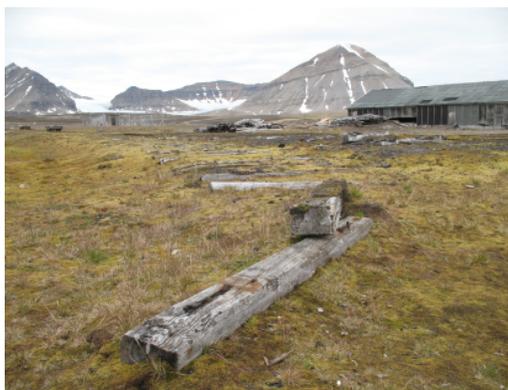
Figure 3. Old materials spread on the ground – a typical sight on Svalbard.

In the period 2002-2008, we examined around 100 protected buildings and building remains around the archipelago of Svalbard. Furthermore, in 2009 a total of 24 buildings, building structures and various drift wood were investigated (Fig. 3). On Svalbard, all building materials from 1945 or earlier are protected by law as cultural heritage. Sampling is for that reason strongly regu-

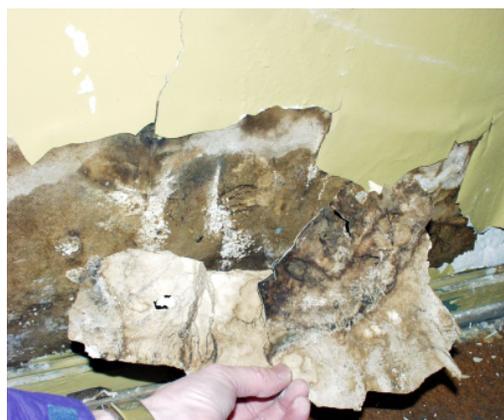
Figure 5. Extensive decay by *Coniophora puteana* in a water damaged wall.

The damages observed were mainly on wood in soil contact, but decay also occurred in roofs and walls. *Coniophora puteana* (Fig. 5), Corticiaceae sp., *Sistro-*

Even if conditions for wood-decaying fungi are marginal, we have observed that local attacks of *Coniophora puteana* can be extensive, showing that the ecological condition for growth of fungi in buildings on Svalbard occasionally can be very favourable (Fig. 5). In one case of established growth of *C. puteana*, in an unheated trapper's cabin, we could even observe a considerable growth of the same fungus after one year on a new, sterilized wood sample that had been placed in contact with the attacked wood. This shows that local contamination happens to new material and further that the development can be relatively fast.

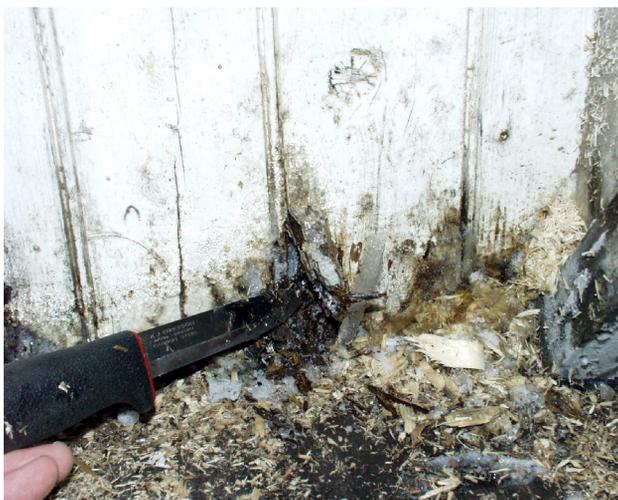
Figure 6. Typical growth conditions for *Leucogyrophana mollis* in lower part of walls, close to soil.

Blanchette et al. (2008) reported that they did not find any brown rot fungi in their material of decayed wood in Arctic Canada and damages found in Antarctica are caused by few species of soft rot fungi (Arenz and Blanchette 2009, Arenz et al. 2006, Held et al. 2005, Blanchette et al. 2004). On Svalbard, we found brown rot fungi to dominate and that the most common fungus causing decay of wood indeed was the brown rot fungus *Leucogyrophana mollis* (Figs. 6, 7).

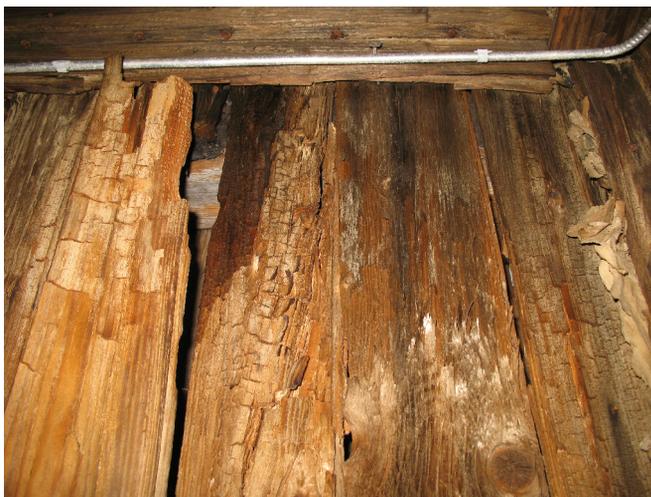
Figure 7. Extensive brownrot decay in upper part of wall caused by *Leucogyrophana mollis*.

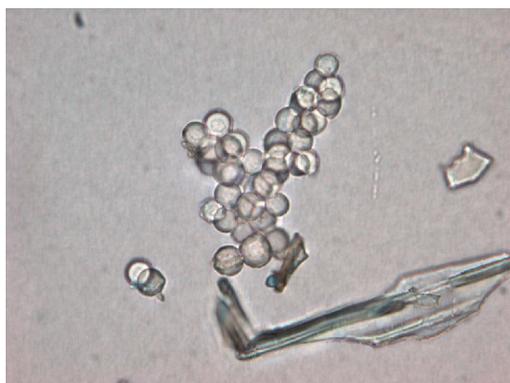
Figure 8. Chlamydospores of *Leucogyrophana mollis*.

One factor that might partly explain the successful growth for *L. mollis* on Svalbard can be its pigmented, thick-walled chlamyospores, because they probably provide resistance against UV-light, cold climate and dry periods (Fig. 8).

In 'building mycology' the species is known as *Leucogyrophana mollis*. A description of the fungus together with ecological observations can be found in Harmsen (1982). When fruiting bodies are missing, an important identification character is the presence of thick-walled, yellowish chlamydospores. These are produced by the vegetative mycelium, and are usually found in large amounts on the timber surface (Fig. 8). But production of chlamydospores is also common in other *Leucogyrophana* species, for example *L. subillaqueata* (Eriksson and Ryvarden 1976).
