**Timber pile foundations
in Longyearbyen:**
a guidance for simple and
preliminary assessment

This booklet is made as result of the “Pelefundamenter og klimaendringer” project (“Pile foundations and climate change”) supported by the Svalbard Environmental Protection Fund (project reference number: 14S95579). The present booklet is made primarily for prospective buyers or owners of real estate in Longyearbyen. It can be also useful for other readers interested in the topic.

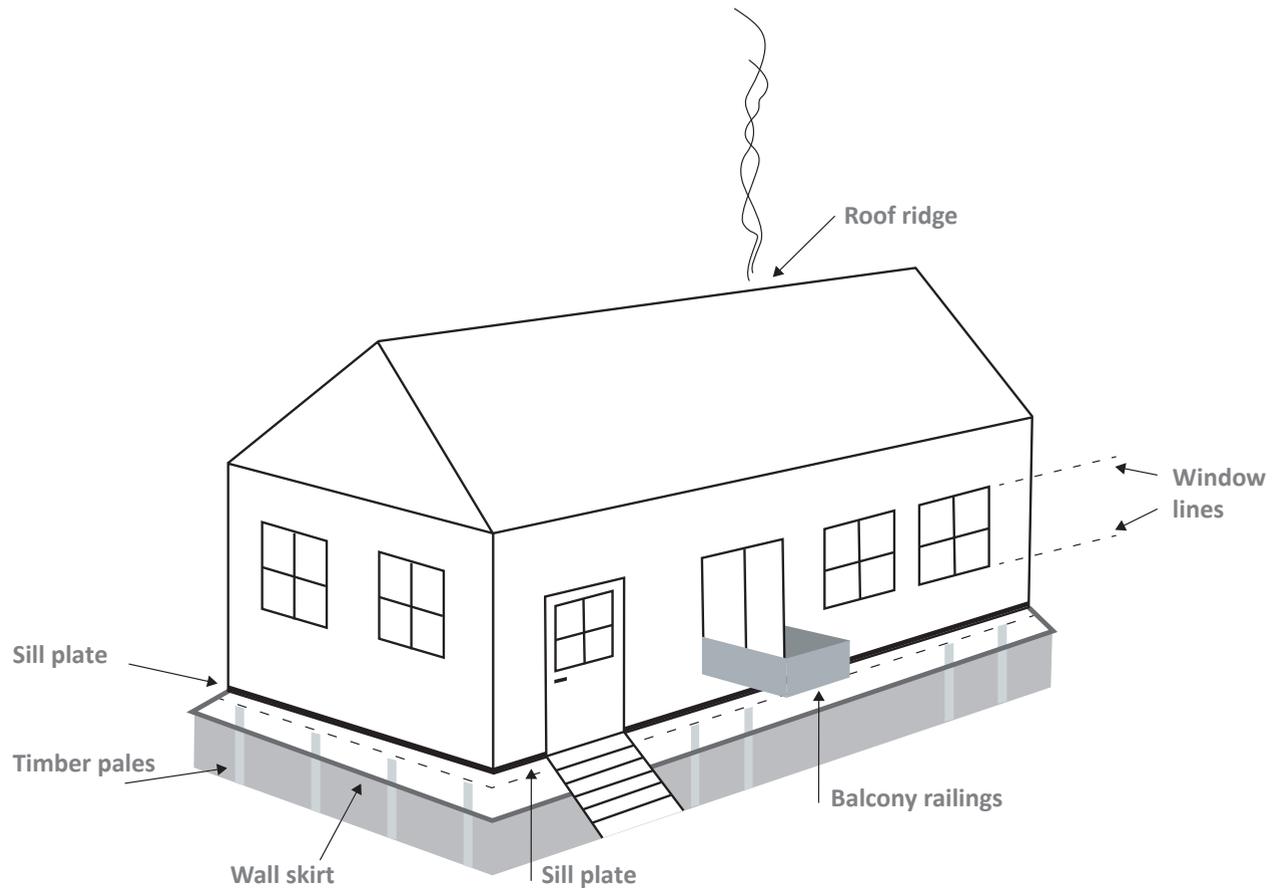
Figure 1. Typical facade elements, geometry of which shall be controlled during visual inspection (Figure: Sinitsyn A., SINTEF).

<p>Step 2. Visual and instrumental inspection of the upper structure.</p>	<p>Cracks in bearing elements such as horizontal, vertical and oblique beams. Note that these elements can be hidden behind paneling or other decorative elements.</p> <p>Cracks on concrete/brick walls supported by timber piles.</p>	<p>Defects (as cracks, etc.) and deformations (as inclinations of facade elements or flooring), issues with opening of windows and doors of the upper structure may signalise presence of uneven settlements of foundations caused by either, pile damage (rupture) or settlement of piles.</p>
	<p>Inclination or bending of the roof ridge, bottom sill, balcony railing, window line, wall skirt (Figure 1). All such facade elements shall be straight (Figure 2).</p> <p>First impression on inclination of the facade elements can be obtained after visual inspection. As a second step, levelling of facade elements with laser leveller can be performed.</p> <p>It is assumed that facade elements (as window line) were originally in level, deviation from horizontal position signalise settlements.</p> <p>This method is limited for use at facades of a building. Settlements of internal piles cannot be assessed with this method. Levelling with laser leveller was used to make assessment of many foundations in Longyearbyen, ([14]).</p>

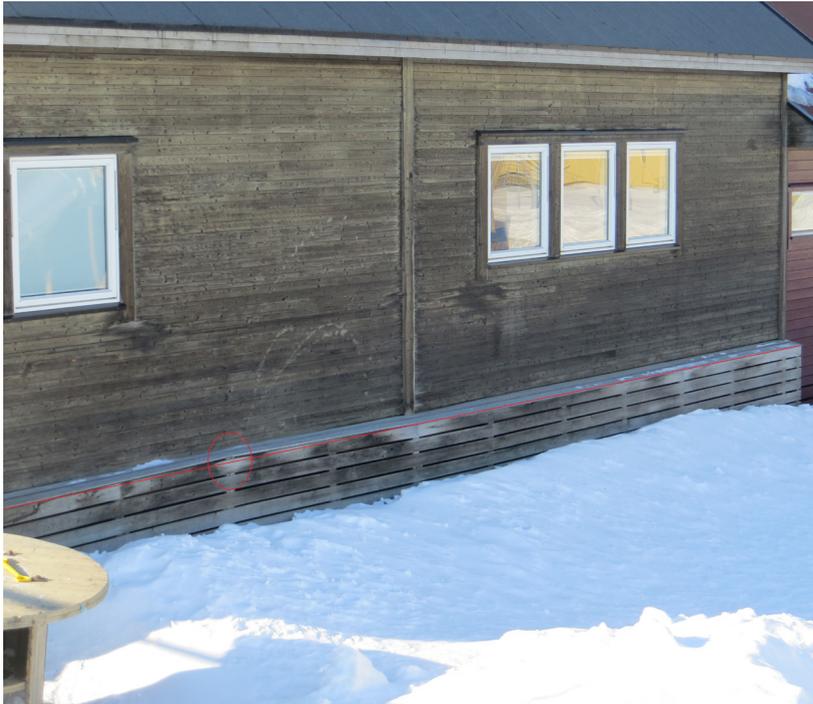
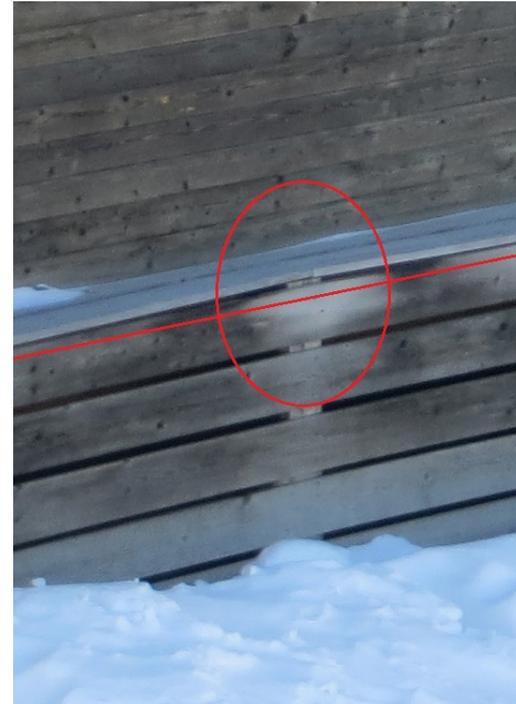
Figure 2. Example of deformed wall skirt (Photo: Sinitsyn A., SINTEF).

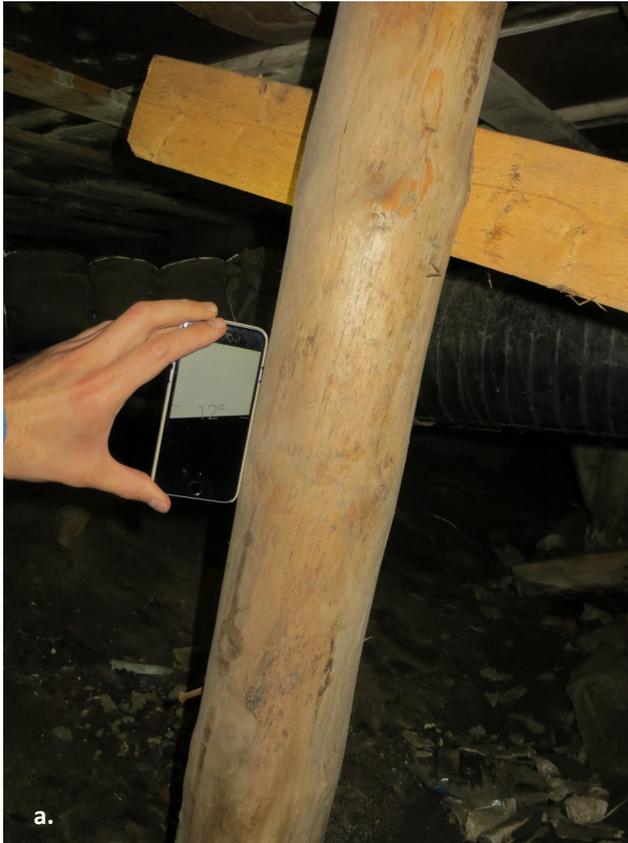
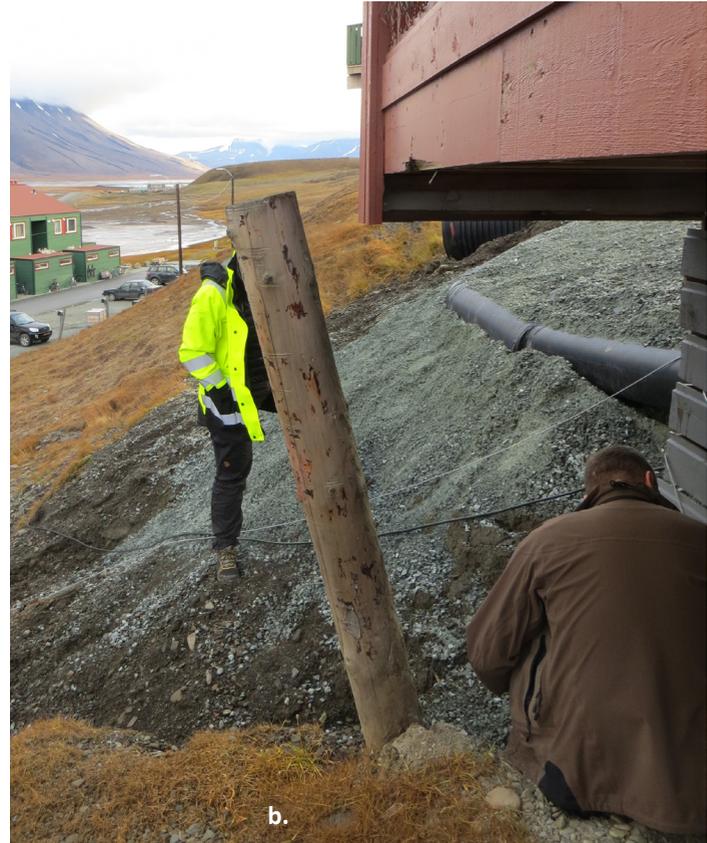
Figure 3 (a, b). Inclined piles (12°) at buildings located on slope terrain in Longyearbyen (Photo: Sinitsyn A., SINTEF)

<p>Step 3. Inspection of foundation (upper part).</p> <p>This section is largely based on recommendations presented in section "2.4.3. Defects and damage survey", [2].</p>	<p>Inclination of piles of buildings situated on slope terrain (Figure 3).</p>	<p>Deviation from vertical position for number of piles may indicate action of slope processes as solifluction¹ on foundation system. Inclination of piles may signalize the insufficient resistance of foundation system to action from slope processes.</p>
	<p>Detection of missing (possibly by empty mortises) or new foundation members and supportive elements as oblique beams.</p>	<p>Missing foundation members might have been removed due to damage caused by overloading.</p> <p>Incorporation of new members can be needed for strengthening of original construction for some reason (when loads appear to be higher than foreseen, and/or rotting processes unexpectedly took place).</p>

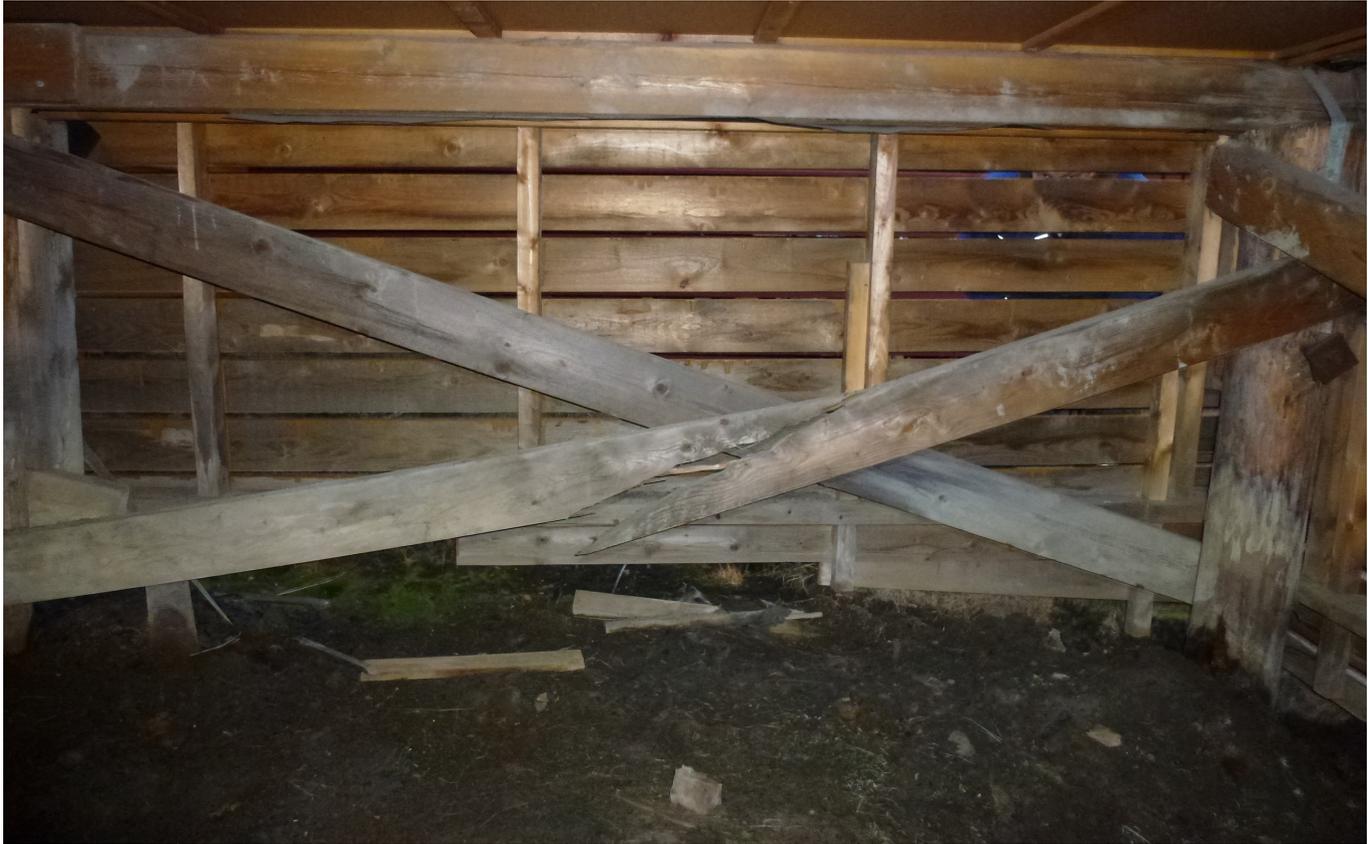
Figure 4. Rupture of a foundation member (Picture: SWECO).

<p>Visual detection of indicators of mechanical damage of piles or other members of foundation system (as oblique or horizontal beams), such as:</p> <ul style="list-style-type: none"> • Complete failures: a pile/an element has a rupture affecting the whole cross section (Figure 4). • Structural distress as cracks or failures of joints. <p>One should, however, bear in mind that drying fissures hardly affect the load-carrying capacity when they are parallel to the beam/column axis (see Figure 5), but they can be decisive when they deviate from this direction, [16].</p>	<p>Indicators of mechanical damage, in general, signalise the overloading of a foundation member (the member can be intact or rotten at some degree).</p> <p>Structural distress of horizontal and oblique members may indicate overloading due to slope processes (solifluction).</p>
	<p>Visual detection of areas of fire or biological damage (Figure 6).</p>	<p>Areas affected by fire or decay have decreased (up to absent) strength.</p>

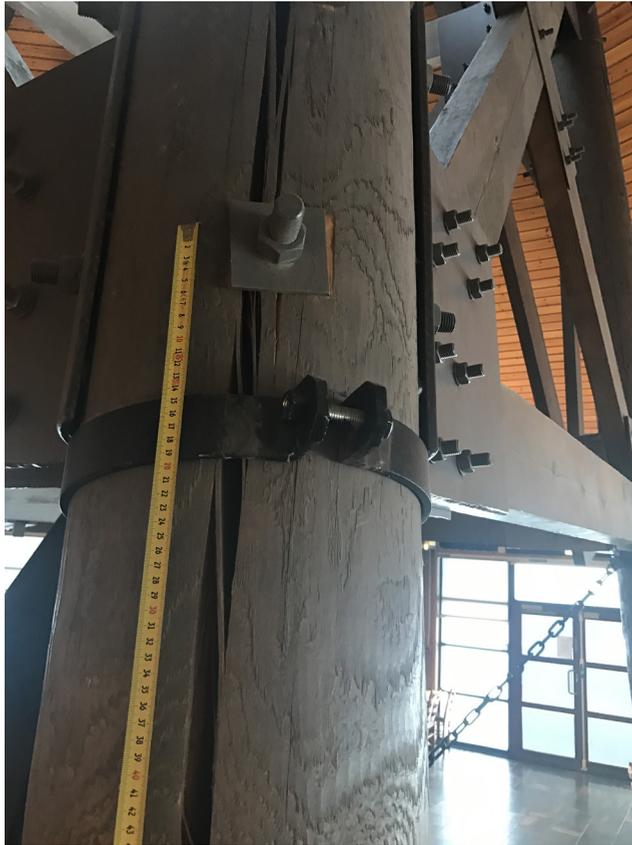
Figure 5. Example of drying fissures hardly affect the load-carrying capacity which are parallel to the column axis (Photo: Sinitsyn A., SINTEF).

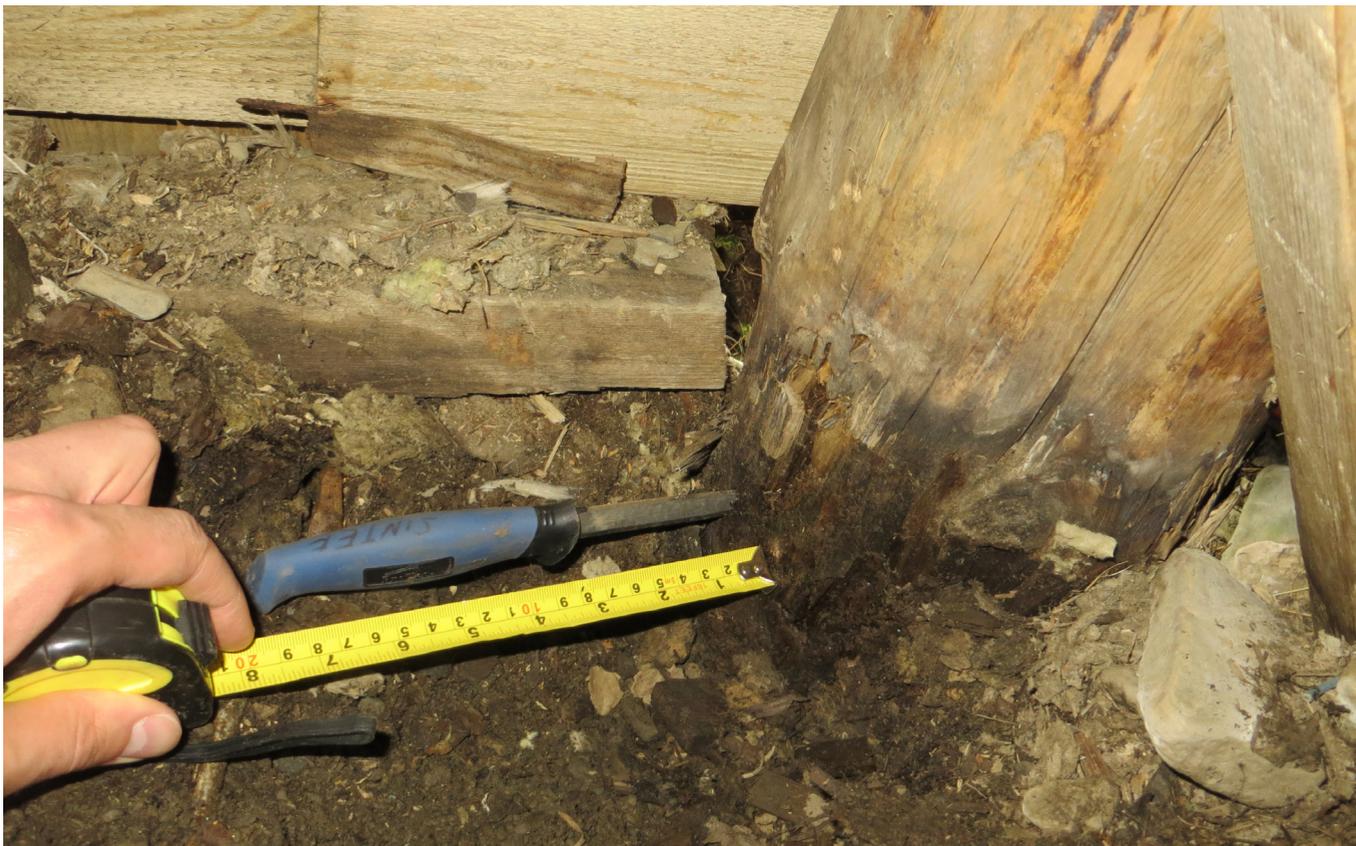
Figure 6. Visual detection of rotten pile elements (Photo: Sinitsyn A., SINTEF).

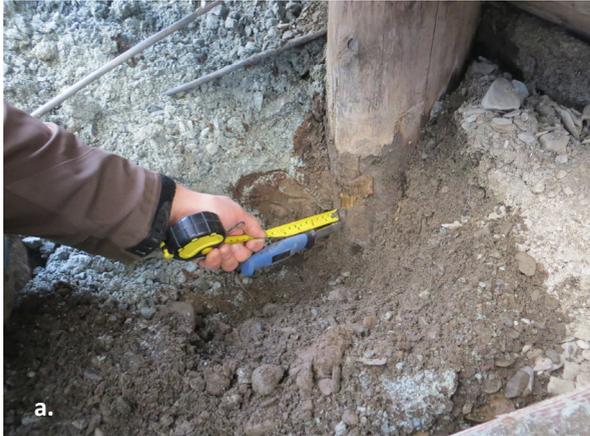
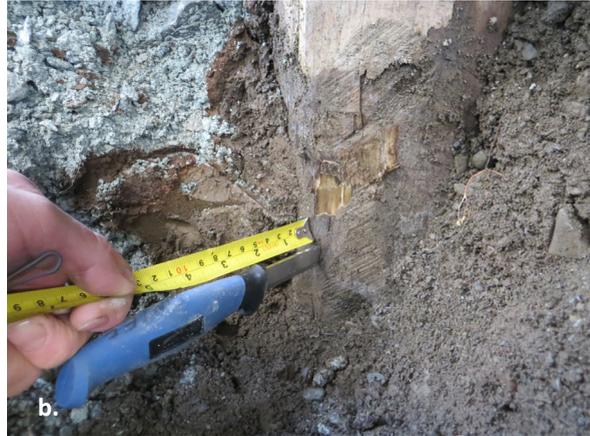
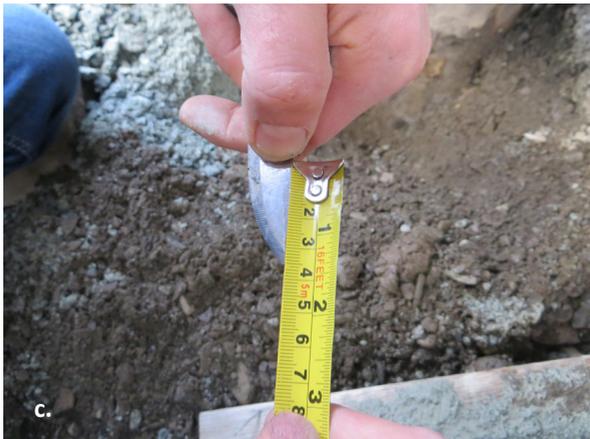
Figure 7 (a-c). Contact inspection of foundation fabric by penknife (Photo: Sinitsyn A., SINTEF).

<p>Physical inspection of foundation fabric. Visually intact areas can experience decay of both, outer layers and of central part of an element. One can recommend to check timber quality above and below ground surface. It is most convenient to perform such operation in late summer/early autumn when it is possible to dig on the whole depth of the active layer as it reaches maximum thickness in the end of summer season.</p> <p>The following procedures may be used for assessment of timber quality:</p> <ul style="list-style-type: none"> • Penetration resistance (destructive method). A technical equipment or penknife can be used. A knife freely penetrates into fully rotten part of a pile. One may however expect difficulties in penetration of a knife through intact outer layer into rotten (if any) inner part of a pile (Figure 7). • Drill resistance (destructive method). Differences in resistance when drilling into sound wood, and when a drill passes through a crack or void, or when drilling into decayed wood can be registered [17, 18]. In other words, resistance when drilling through rotten part decreases compared to intact parts. 	<p>Timber members affected by decay are characterised by decreased strength.</p>
